Davidson County Tornado

...2 TORNADO TOUCHDOWNS CONFIRMED NEAR IN DAVIDSON COUNTY NORTH CAROLINA...

Location...Linwood in Davidson county North Carolina

Date...03/28/2010

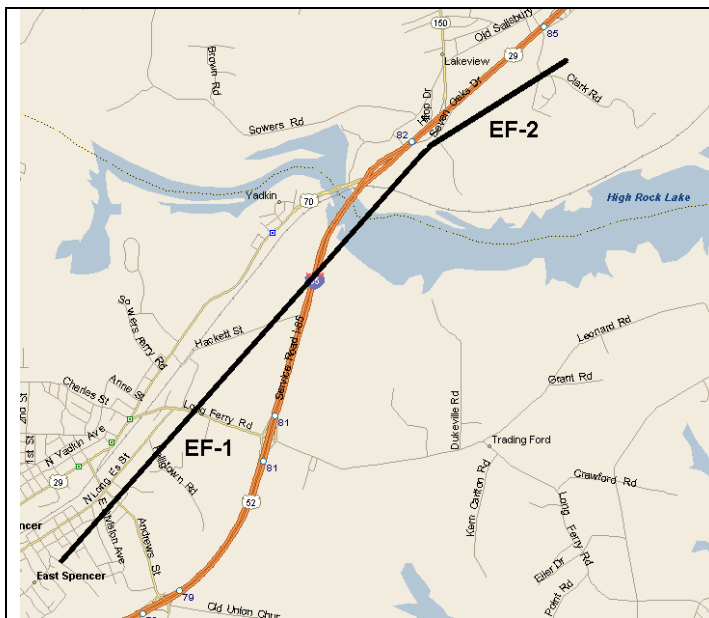
LINWOOD TORNADO PATH.

At approximately 655 pm EDT a tornado touched down south of Seven Oaks Drive in a wooded area. Ten to fifteen hardwood trees were either sheared off or uprooted. Minor structural damage was sustained at a nearby residence when a carport was ripped from a brick home. Two out buildings were also destroyed. The tornado tracked northeast about a half of a mile across an open field before it proceeded to damage a vacated steel framed flea market building. The tornado glanced the southeastern corner of the metal building...tearing it away from the remainder of the building. The debris field from the metal building was blown one mile downstream from the site. Sections of sheet metal from the building were found twisted around several trees and high tension power lines. In the adjacent chestnut grove mobile home park...located at the Intersection of Clark Road and Windy Hill Drive...three mobile homes were completely destroyed and two others sustained significant damage. Approximately five people were treated for injuries...with two being transported to a local hospital. There were no fatalities with this event. The tornado quickly dissipated in a wooded area northeast of Clark Road. The total length of the damage path was approximately one mile in length and approximately 50-75 yards in width. Damage was consistent with wind speeds of 100-120 mph...rating this an EF-2 tornado on the Enhanced Fujita Scale.

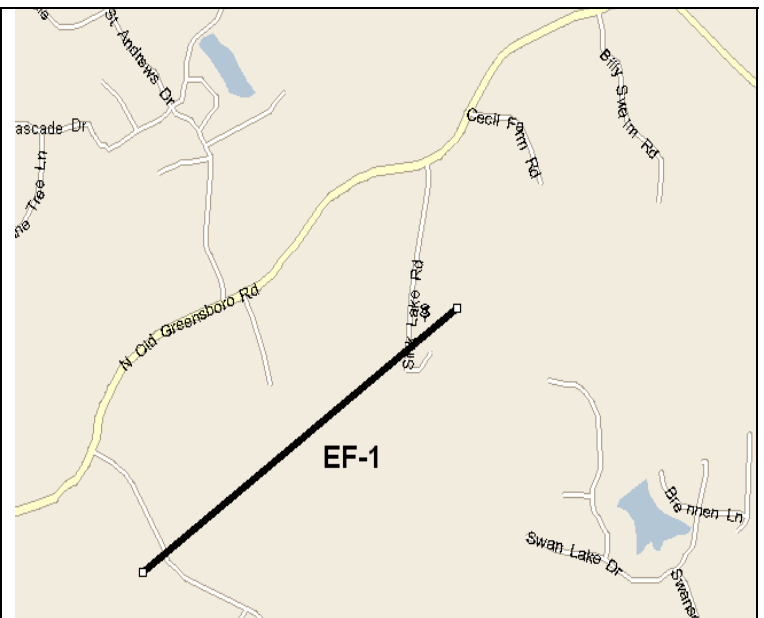
SINK LAKE TORNADO PATH.

At approximately 715 pm EDT a second tornado touched down in a wooded area causing extensive tree damage south of Carpenter Road extension. The tornado tracked northeast across Carpenter Road extension where it caused minor damage to a single family residence when it destroyed the attached carport. The tornado then tracked a half of a mile over a wooded area where it then hit the southeastern corner of the valley mobile home park located off Sink Lake Road. One mobile home was completely destroyed when it was blown from the anchor points and displaced into an adjacent lake. Four occupants were inside the home and had to swim to shore. Along with the mobile home...the residents full sized SUV was also lifted and deposited into the lake. An additional five to six mobile homes sustained significant damage from fallen trees and flying debris as well as being shifted from their anchor supports. Remarkably...there were no serious injuries. The tornado quickly lifted in a wooded area about 100 yards north of the mobile home park. The total length of the tornado path was approximately 0.7 miles long and 25-50 yards in width. Damage was consistent with wind speeds of 80-100 mph...rating this an EF-1 tornado on the Enhanced Fujita Scale.
